Historic and Future Inlets Along Topsail Island

William J. Cleary

5 October 2014

Historic and Future Inlets along Topsail Island

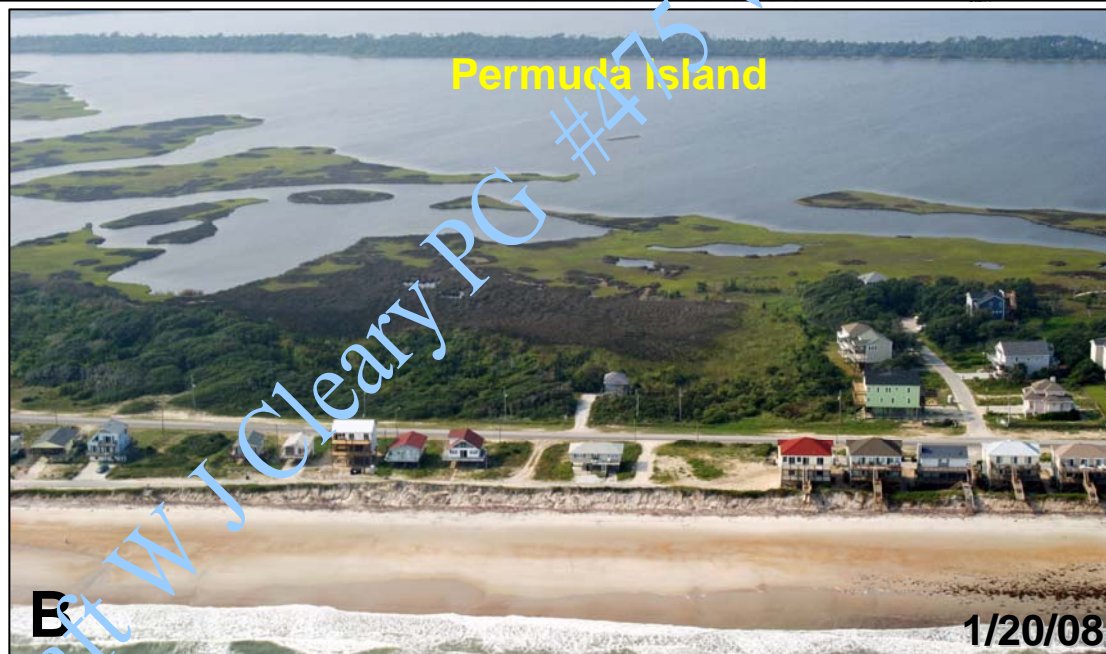
Figure 3. A US C & G S Map (1889) segment depicting a portion of Surf City and North Topsail Beach and aerial photograph of Stump Sound and Permuda Island (Pleistocene Barrier). A. Map show the location of Pleistocene Barriers (beige polygons) within the estuary. Note the different trends of the modern and Pleistocene barriers. Barren Inlet located closed prior to 1840 while Stump Inlet closed in the early to mid 1870s. B. Permuda Is. is the longest of the barriers. Note the lack of an appreciable amount of marsh between the modern barrier and Permuda Island.

The northern portion of Topsail Island is a unique barrier island setting in this area of North Carolina due to the presence of a 10.6 mile long Pleistocene Barrier complex within the estuary that trends at a different orientation than the modern barrier (Figs. 3 and 19-22). This 125 ka old barrier complex extends from its attachment area (spit) near the Surf City Bridge (Fig. 23) to ~.75 mile NE of Alligator Bay on the seaward side of the dredge material islands (Fig. 20). There are 10 barrier segments (remnants) including the barrier spit, and are of variable length. The longest of the island remnants is Permuda Island (Figs. 3 and 23), which is ~1.4 miles long, while the shortest remnant is ~420 ft in length. The old islands are vestiges of their former shapes and have been eroded through time during low stands of sea level. The northern portion of the Pleistocene barrier trend has merged with the modern barrier near the south ramp of the Highway #210 high rise bridge.

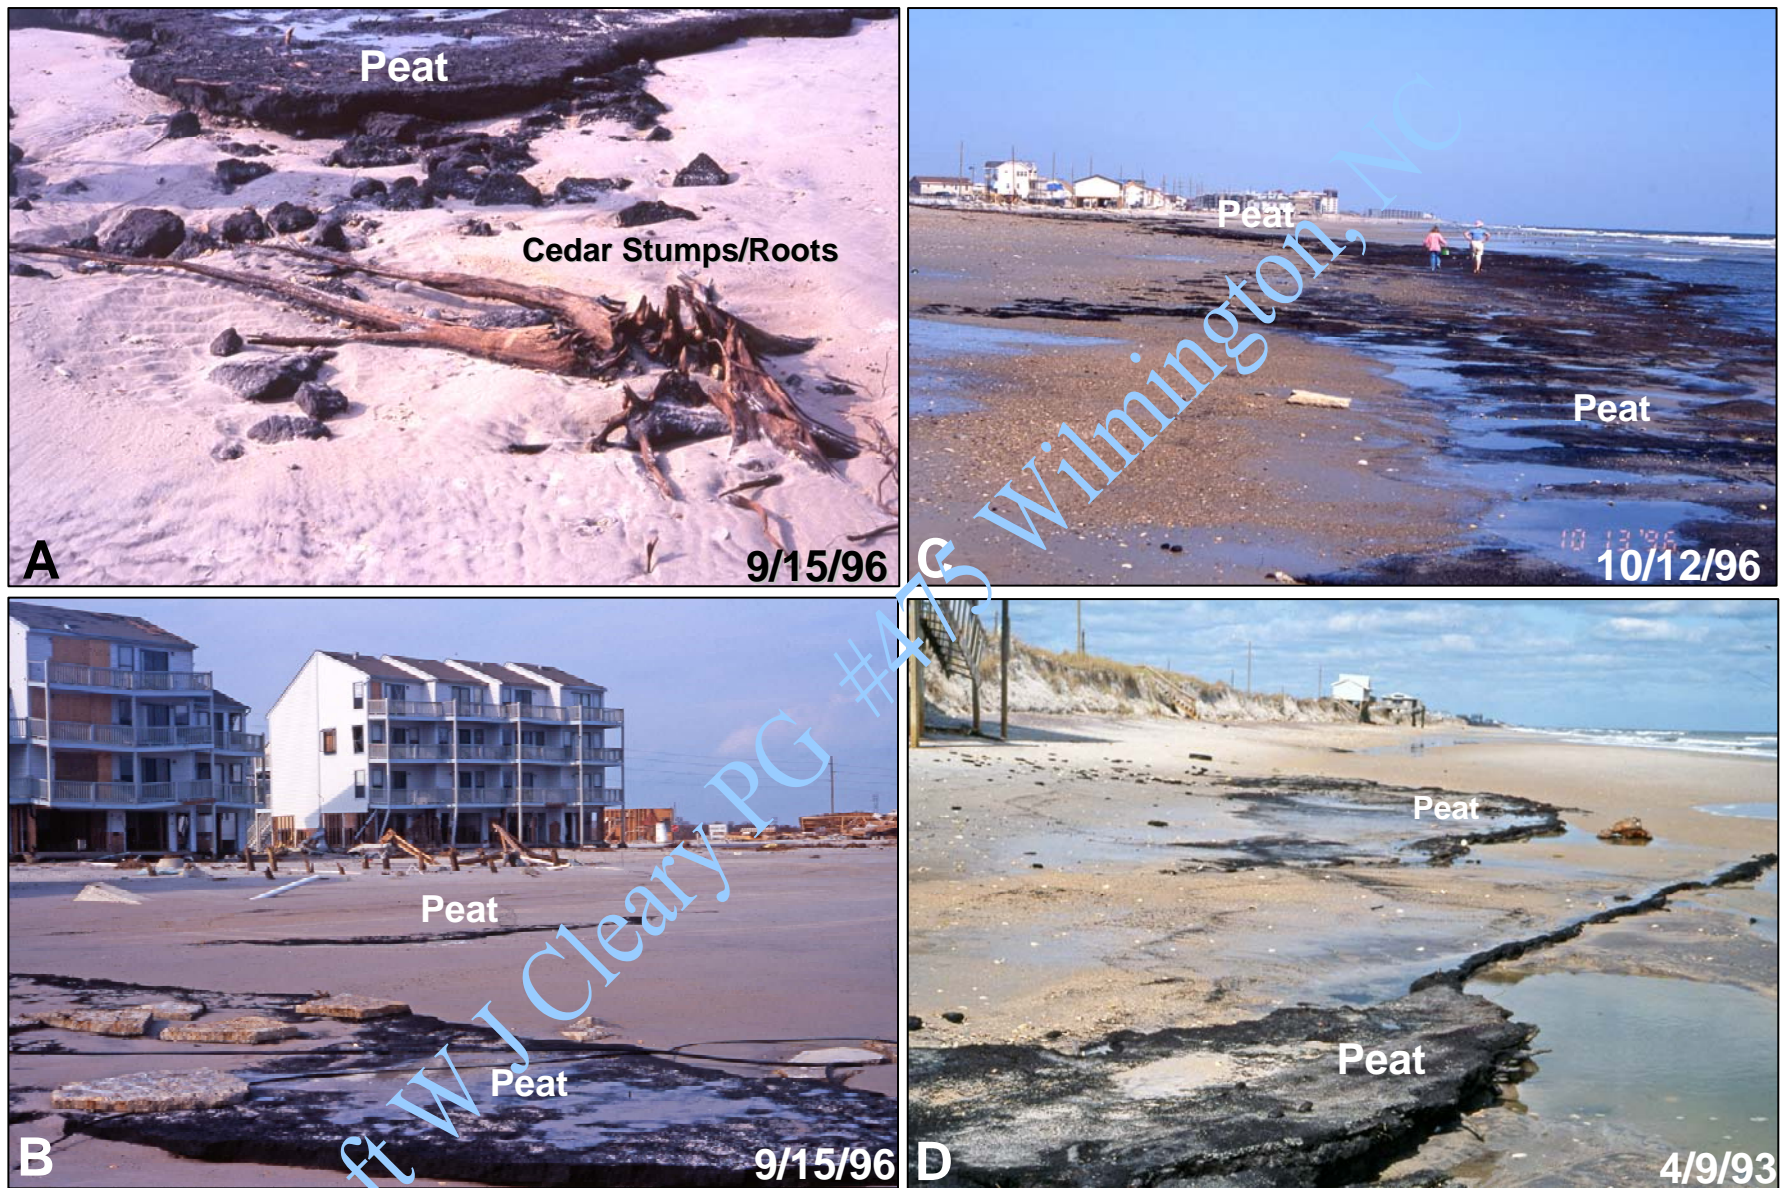
Figure 5. Ground views of peat exposures along North Topsail Beach (NTB). A. View (9/15/06) of high marsh peat exposure along NTB with shrub and cedar stumps. B. View (9/15/06) of road bed resting atop the peat bed. C. View (10/12/96) of beach during low tide condition with extensive high marsh exposure. D. View (4/9/93) of the beach along the southern portion of NTB (Topsail Drive). The extensive peat exposures along this shoreline reach indicates no inlets have been active in this area in the recent past.

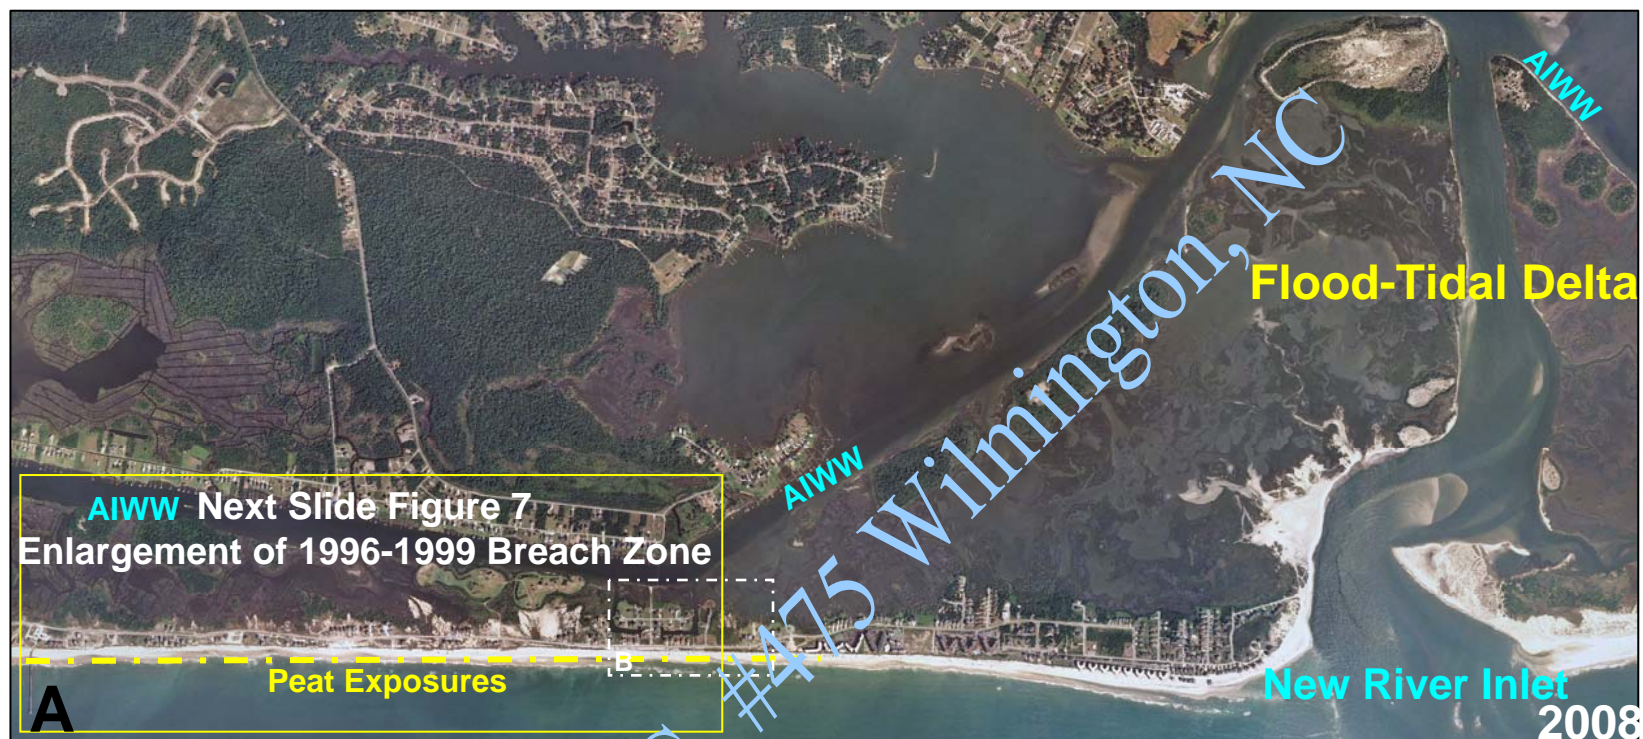
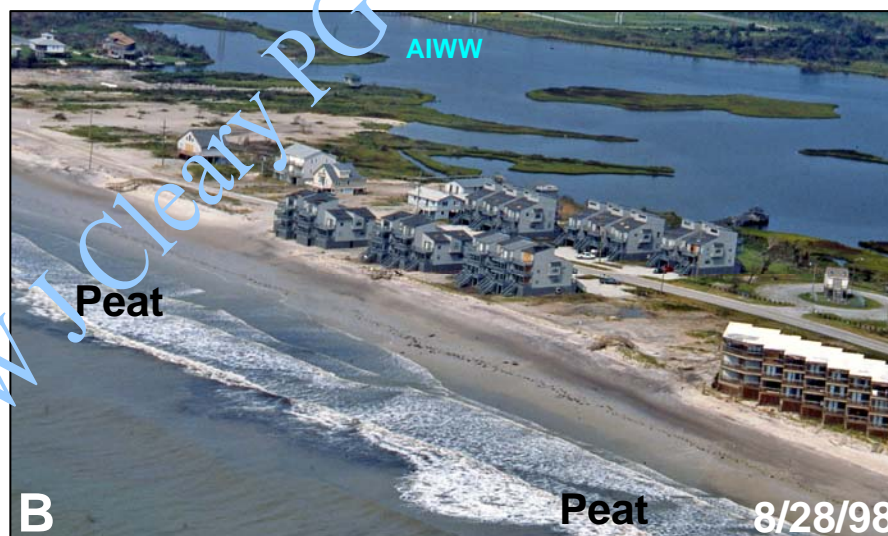
Figure 6. Photographs depicting NTB and New River Inlet. A. Photograph (2008) depicting New River Inlet and adjacent NTB. Note yellow dotted outline refers to Figure 7. B. Oblique view (8/28/98) of peat units in surf zone. Location is referenced in "A" by white rectangle outline.

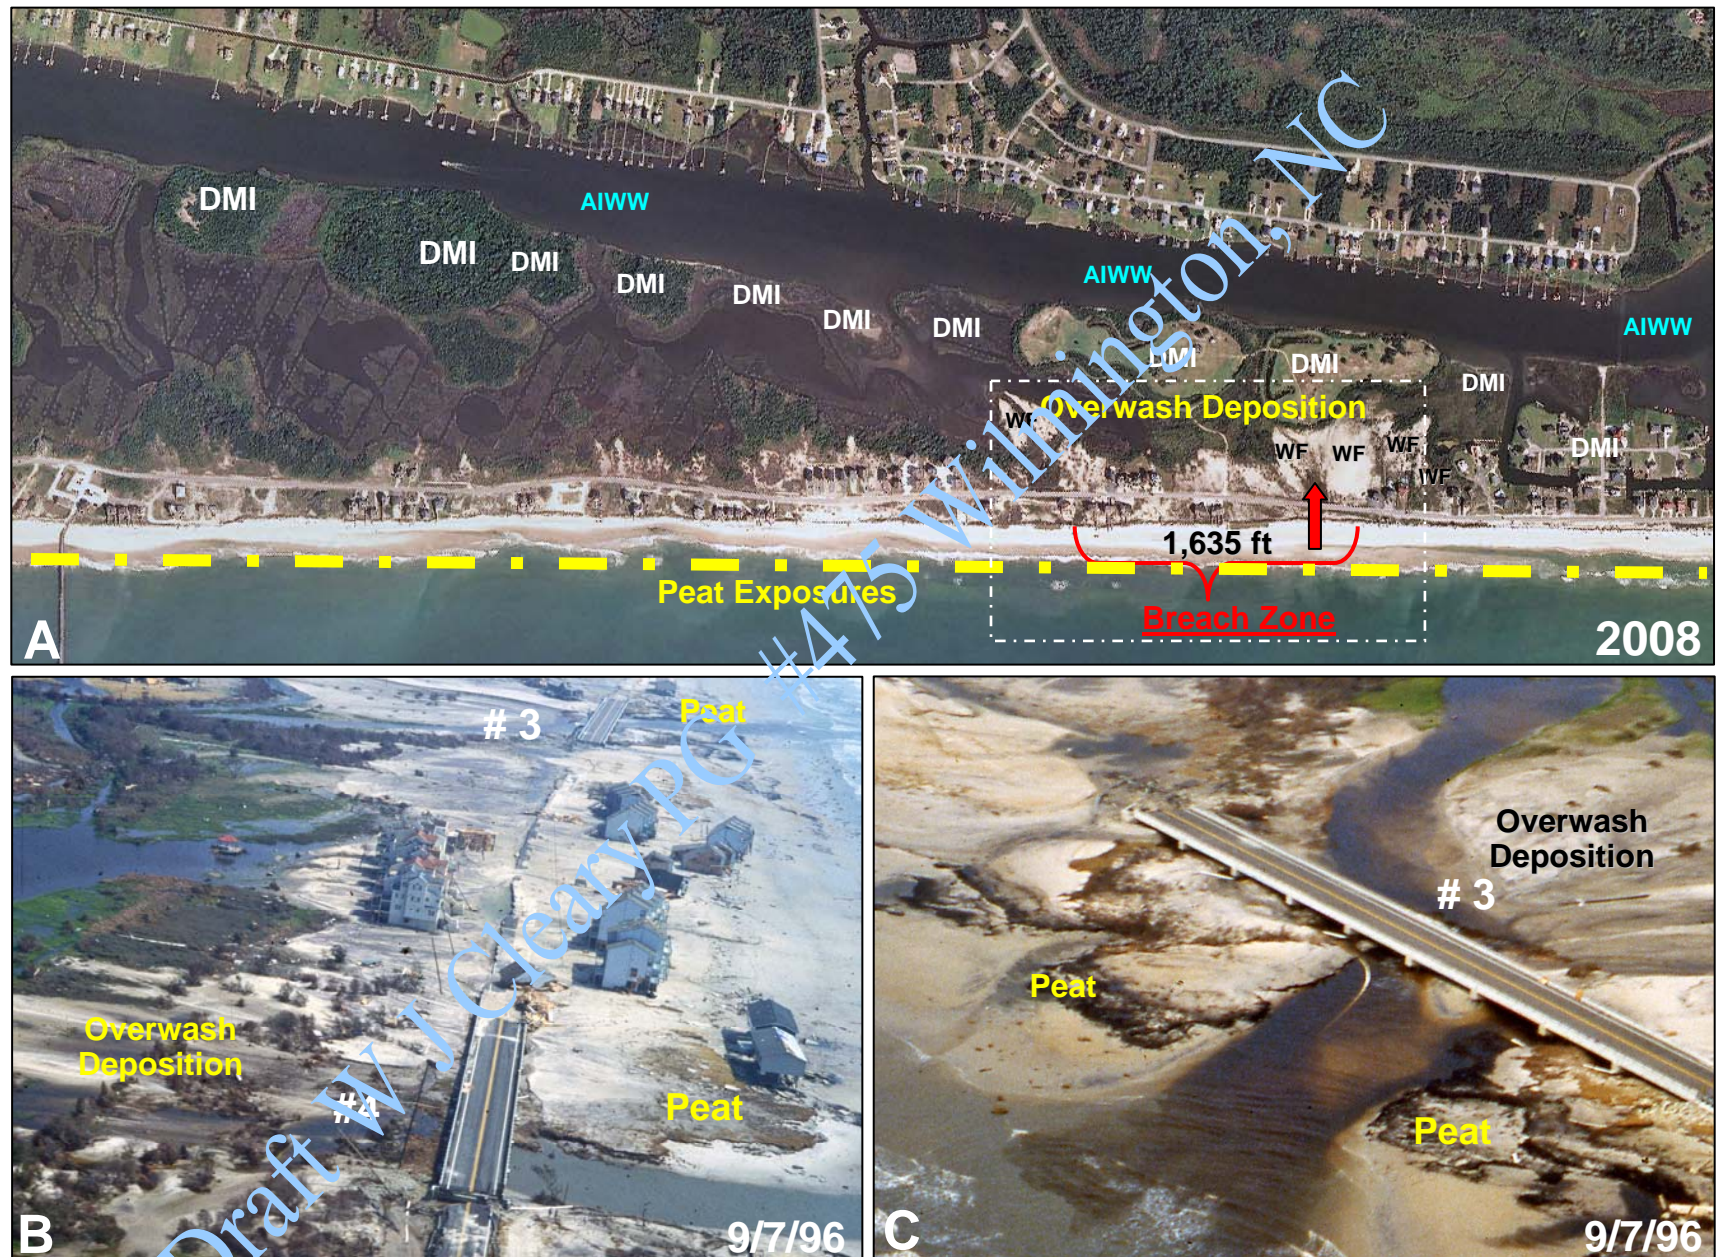
Figure 7. Photographs of NTB depicting distribution of peat exposures A. Photograph (2008) depicting the regional distribution of peat along the oceanfront and the northern breach zone location. Rectangular refers to location of "B" and "C". B. Northward view (9/7/96) of breach sites showing extensive peat outcrops. C. Photograph depicting shallow breach (#3) and washover fan and peat exposures.

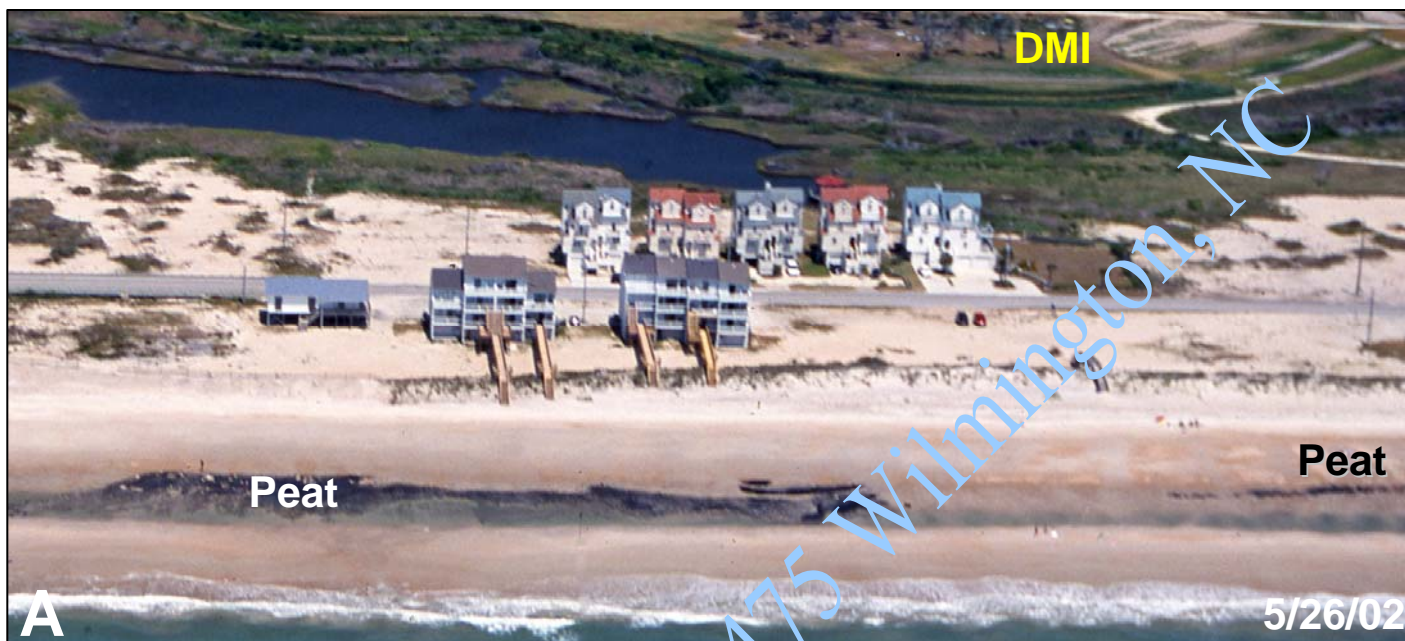
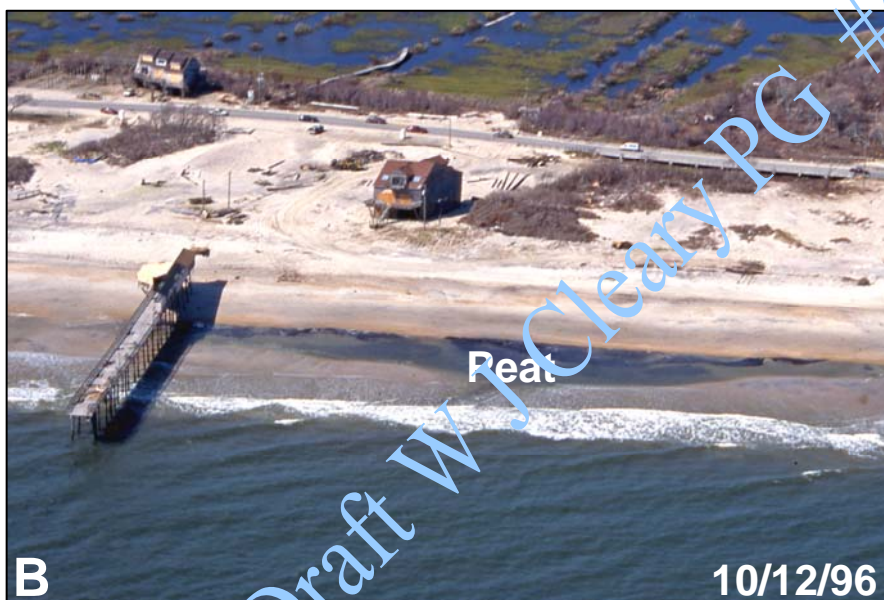
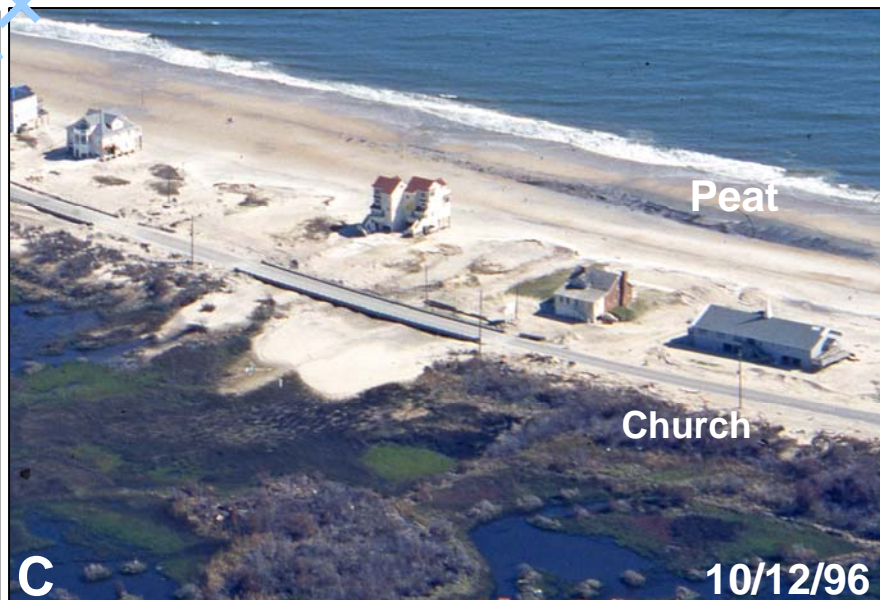
Figure 8. Oblique aerial photographs of the of peat exposures along North Topsail Beach (NTB). A. View (5/26/02) of peat exposure on lower foreshore fronting developed dredge material island (DMI). B. View (10/12/96) beach in vicinity of a NTB pier and peat that is exposed along much of this shoreline reach. C. View (10/12/96) of beach during low tide condition and high marsh peat exposure in vicinity of Baptist Church.

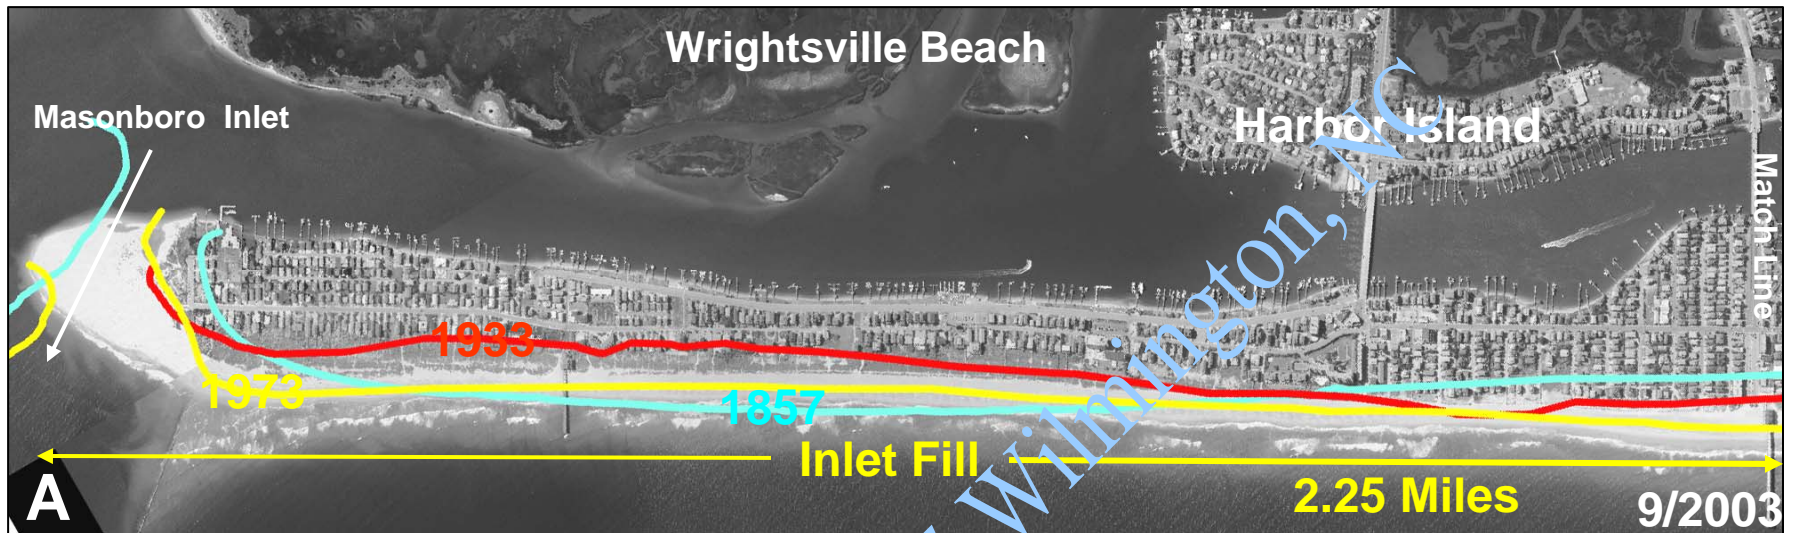
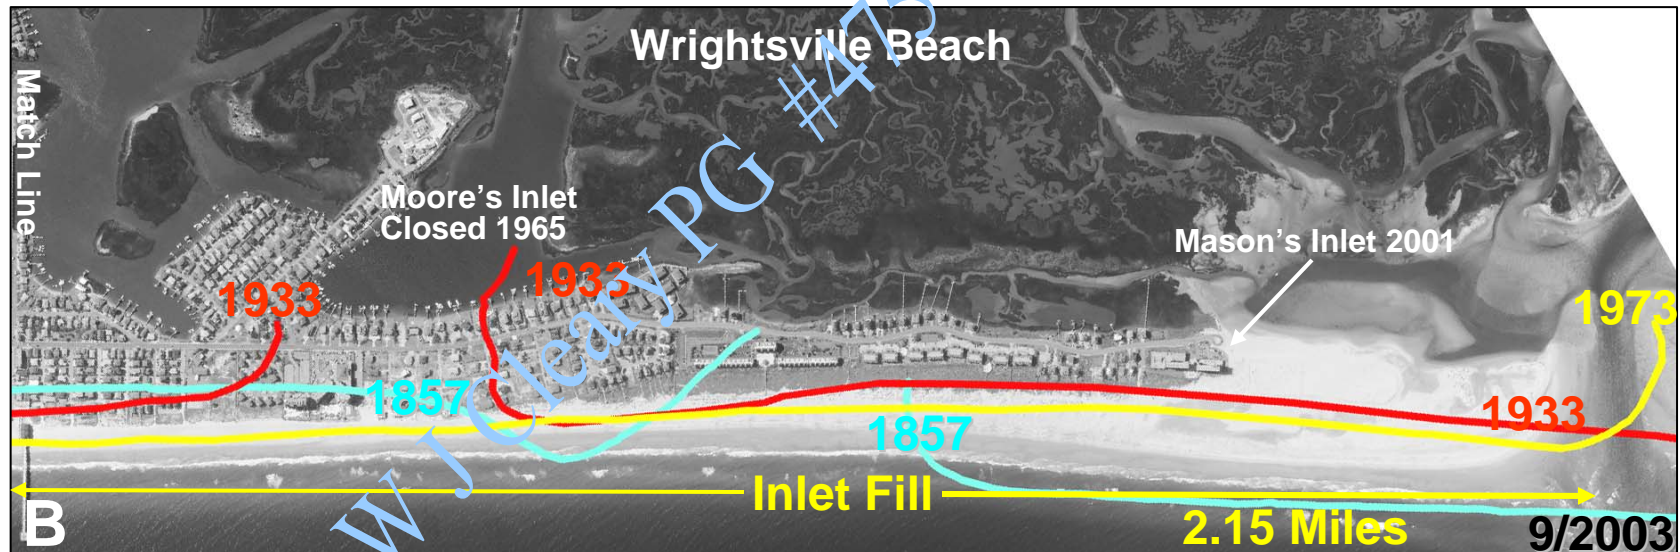
Figure 12. Map of Wrightsville Beach depicting a photograph (9/20/2003) with selected historic shoreline positions. A. Map of the southern portion of Wrightsville Beach depicting the extent of inlet fill. Masonboro Inlet has migrated along the barrier from Harbor Island to its present location. B. Map of the northern portion of the barrier (Shell Island). Moore's Inlet (Wrightsville Inlet) have migrated along the length of Shell Island. Mason Inlet in 2001 was located at the base of the Shell Island resort. All of Wrightsville Beach is underlain by inlet fill and as recently as 1965 was comprised of two Islands.

Wrightsville Beach, for example, is comprised of two barriers (Fig. 12) that were separated by Moore's Inlet that was closed artificially in 1965. Masonboro Inlet, a long-lived inlet, migrated along the entire length of the southern portion of Wrightsville Beach, while Moore's Inlet and its predecessors, migrated along the entire two miles of the northern portion of Wrightsville Beach (Shell Island). In March 2001, Mason Inlet, that forms the northern boundary of the Shell Island, was relocated northward 3,100ft from its 1998 position at the margin of the Shell Island Resort (Figure 12 B). Relocation of the inlet was viewed by nearby residents and local and State agencies to be the most viable management option.

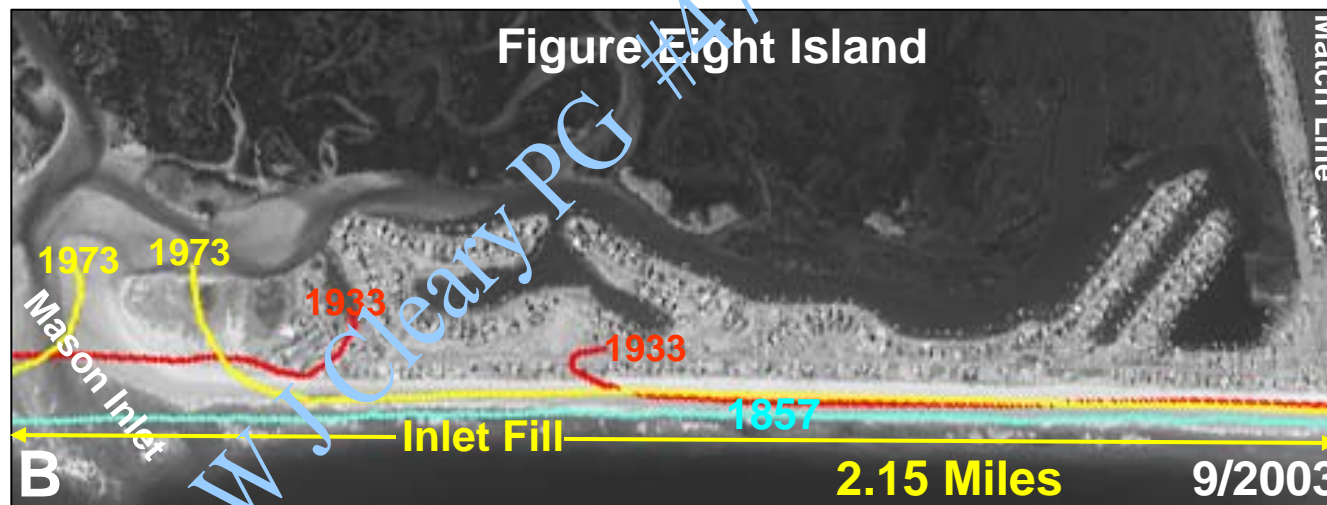
Figure 13. Map of Figure Eight Island depicting a photograph (9/20/2003) with selected historic shoreline positions. A. Map of the northern portion of Figure Eight Island depicting the extent of inlet fill. Nixon Inlet a mid-19th C inlet remained open until 1895. Previous inlets that pre-date the colonial era have migrated along the northern segment of the barrier. B. Map of the southern portion of F8I. Mason Inlet has migrated along the length of the southern barrier segment. Mason Inlet in 2001 was located at the base of the Shell Island Resort before it was relocated northward. Consequently the length of the island has changed depending upon the position and number of inlets.

Mason Inlet opened in the late 19th C along Figure Eight Island (Fig. 13) immediately south of the Causeway on Figure Eight Island. In the 19th C. Figure Eight Island was much shorter in length, and through time has increased in length as Mason Inlet migrated southward and Nixon Inlet (Figure 13A), at the northern end of Figure Eight Island, closed (1895). Elmore's Island, an undeveloped barrier, located northeast of Figure Eight Island is a prime example of a barrier island that is comprised of multiple oceanfront segments of different ages (Fig. 14). Old Topsail Inlet, that had existed prior to 1730, finally closed in 1998 and thereby joined Elmore's and Lea Islands as a single barrier. Currently the northern portion of Lea Island is steadily eroding due to the southward migration of New Topsail Inlet (Figs. 14-16).

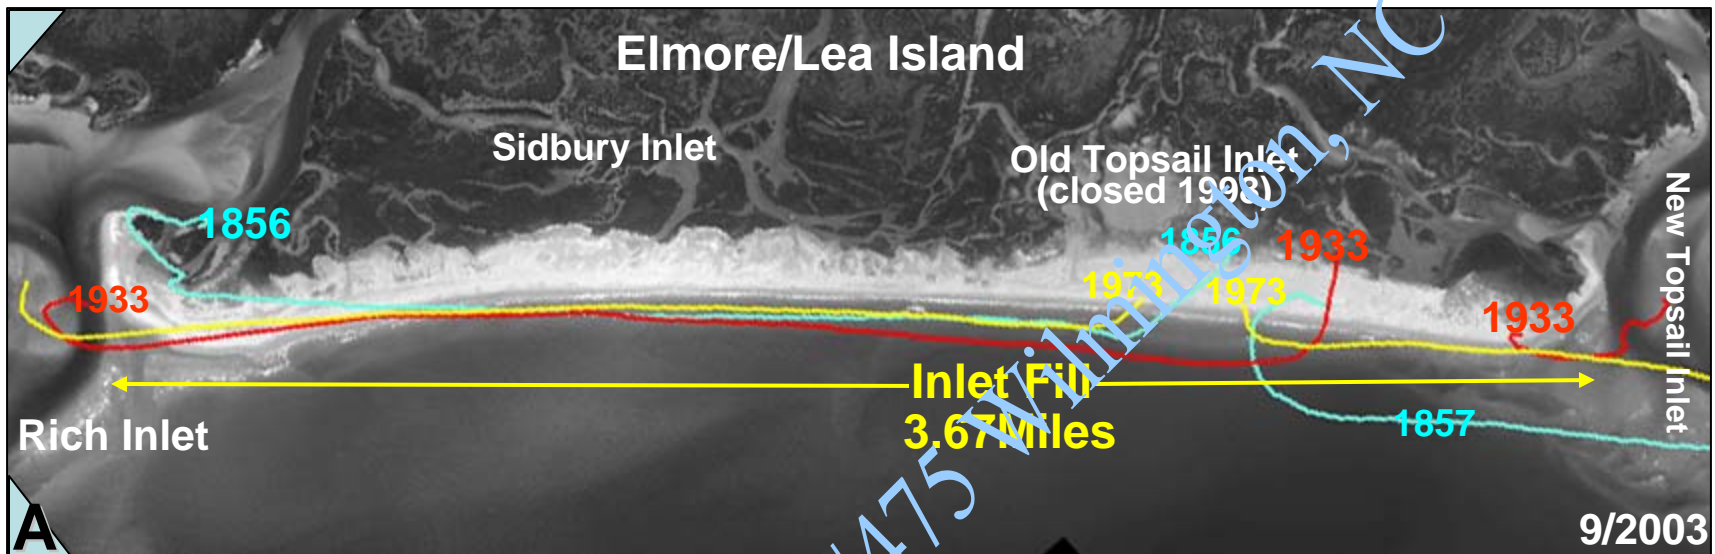
Figure 14. Map of Elmore's Island depicting a photograph (9/20/2003) with selected historic shoreline positions. The barrier shown consisted of two island as recently as 1998 when Old Topsail Inlet closed after a long history of migration. Sidbury Inlet has opened and closed several times during its history. Consequently the length of the islands has changed depending upon the position and number of inlets.

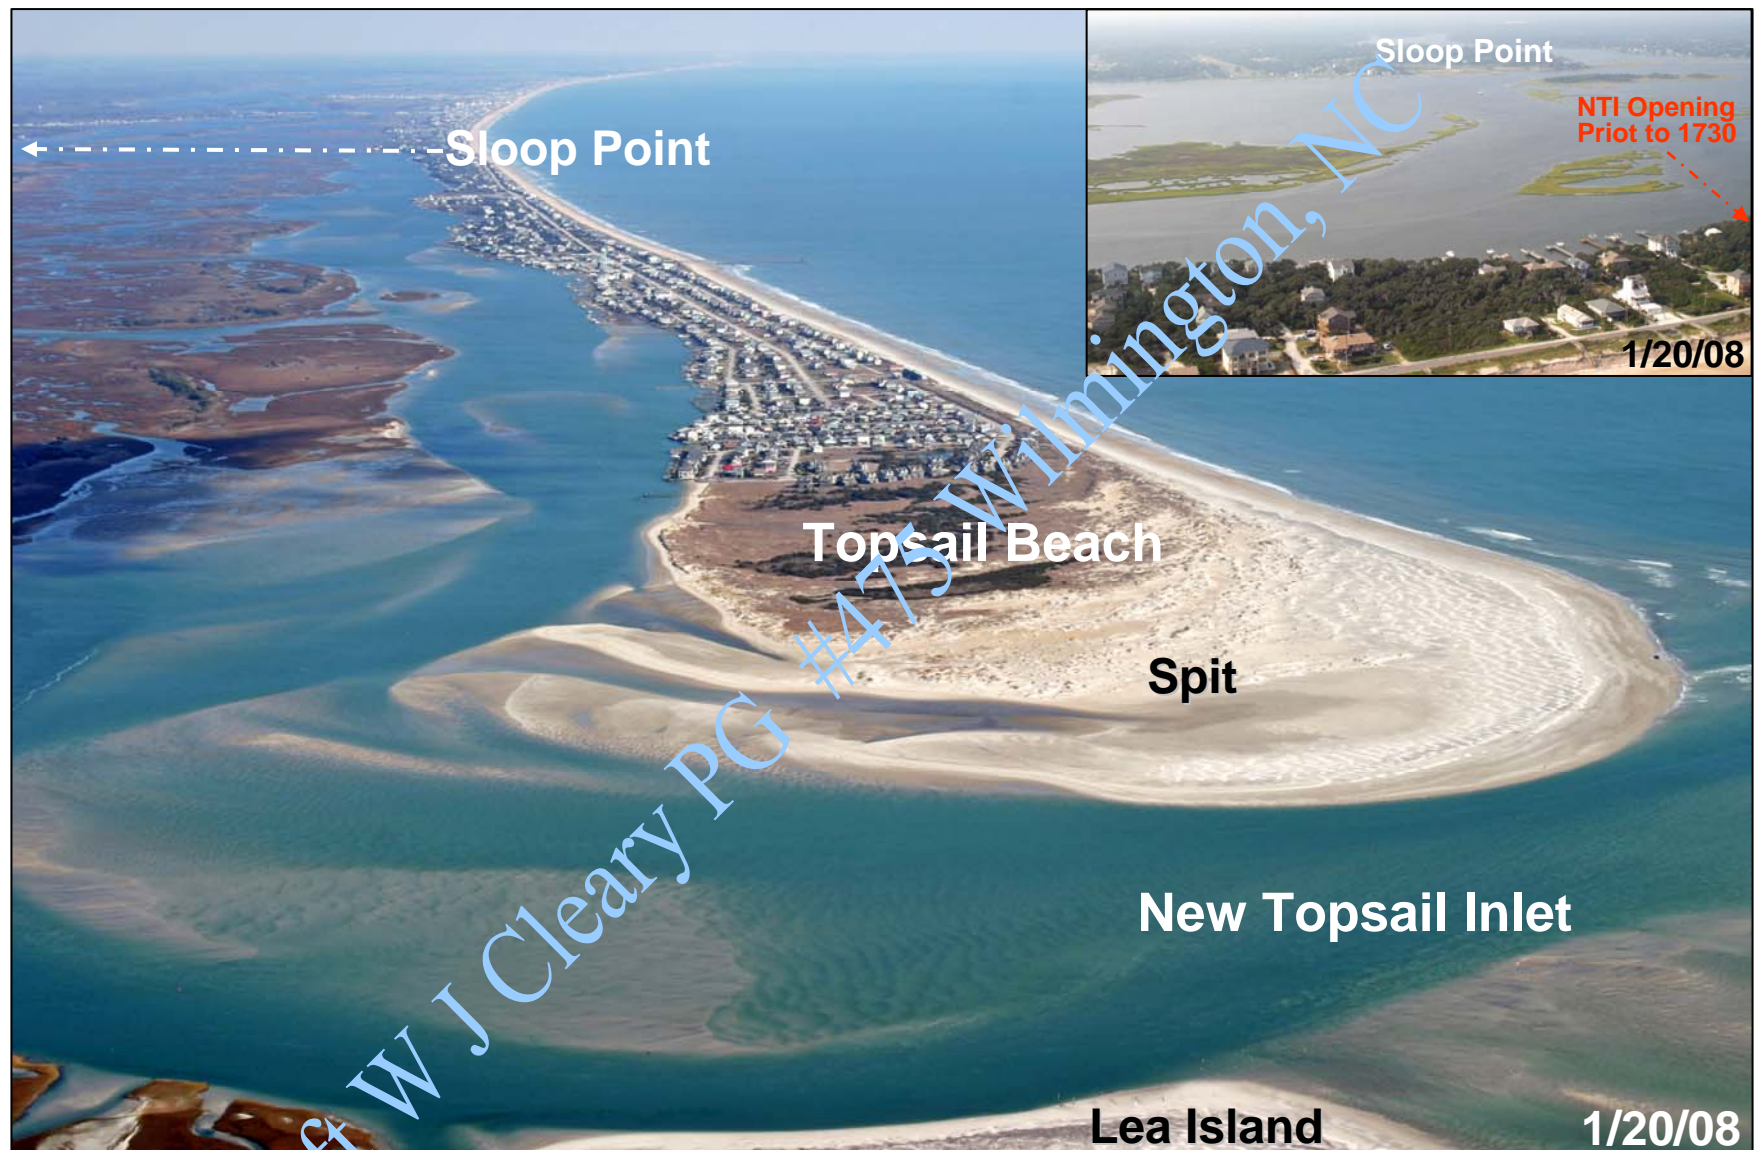
Figure 15. Northward view (1/20/08) of New Topsail Inlet (NTI) and Topsail Sound. NTI opened prior to 1730 and has migrated more than six miles. Note the increasing width of the barrier as it migrates southward. Lea Island (bottom) continues to erode as the inlet shifts in southerly direction. Insert depicts the location of Sloop Point on the mainland and general location where the inlet opened prior to 1730.

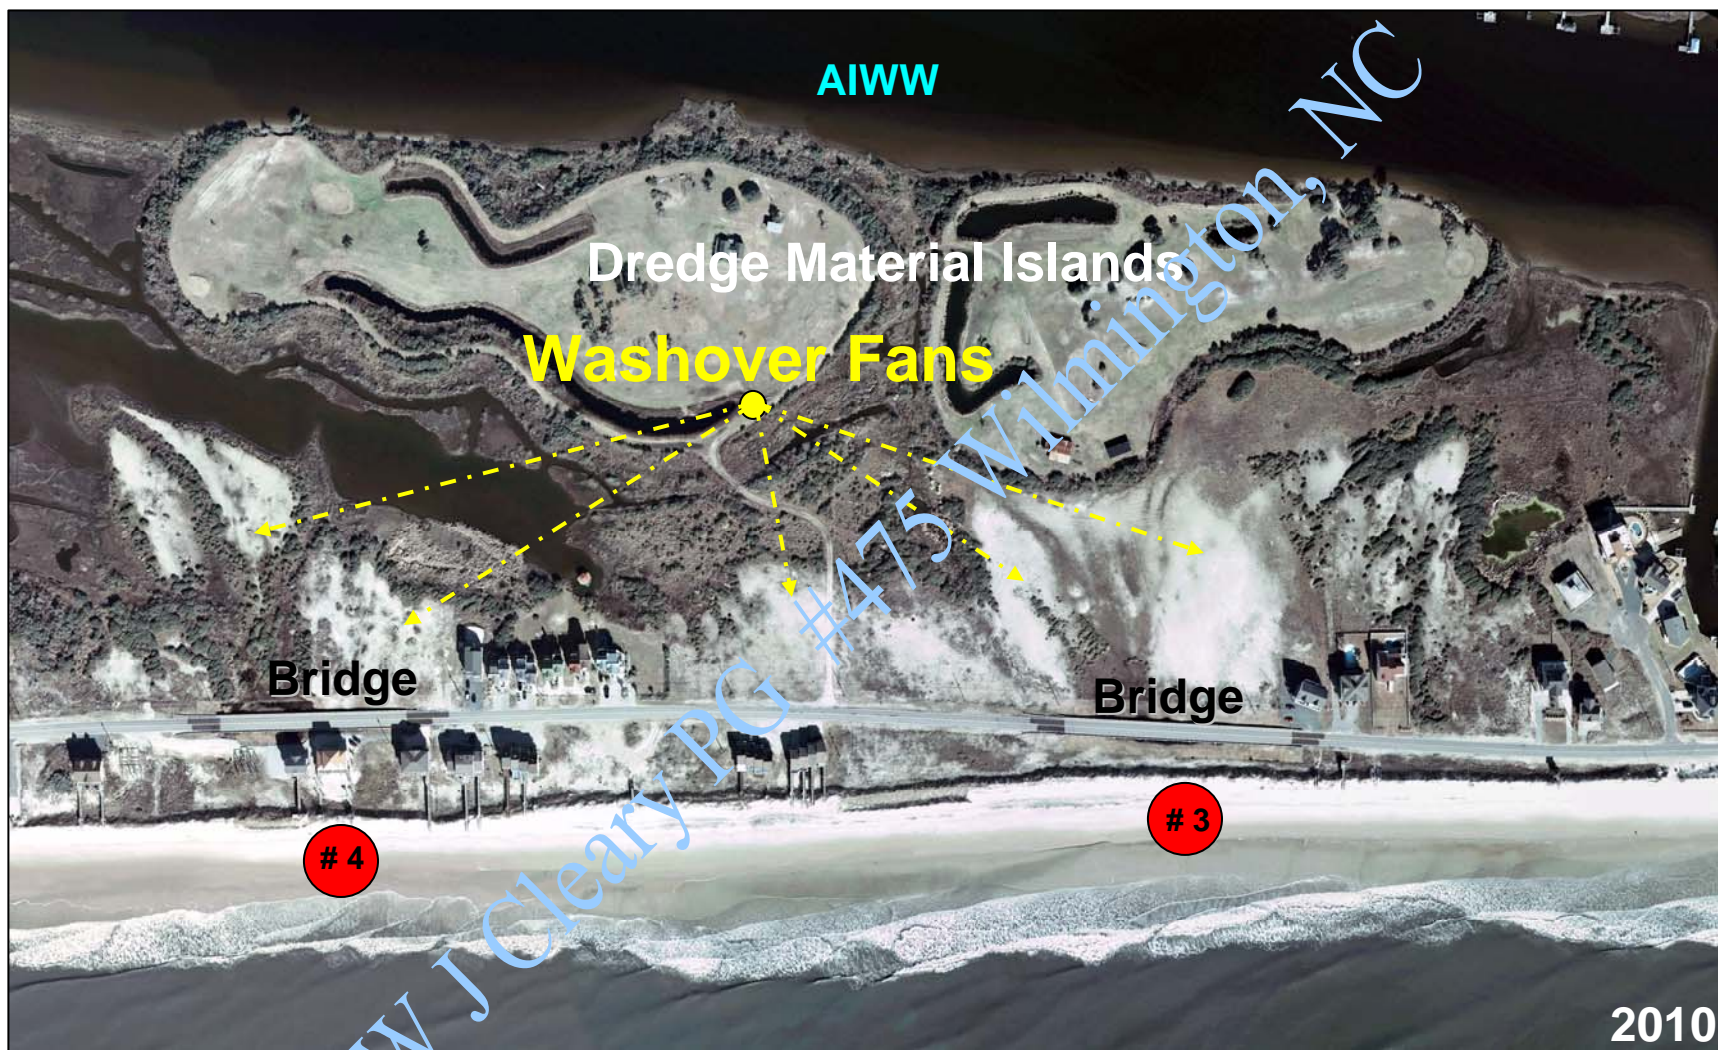
Figure 19. Aerial photograph (2010) showing the NTB breach zone with large washover fans developed near bridge sites. See Figure 7 for oblique views.

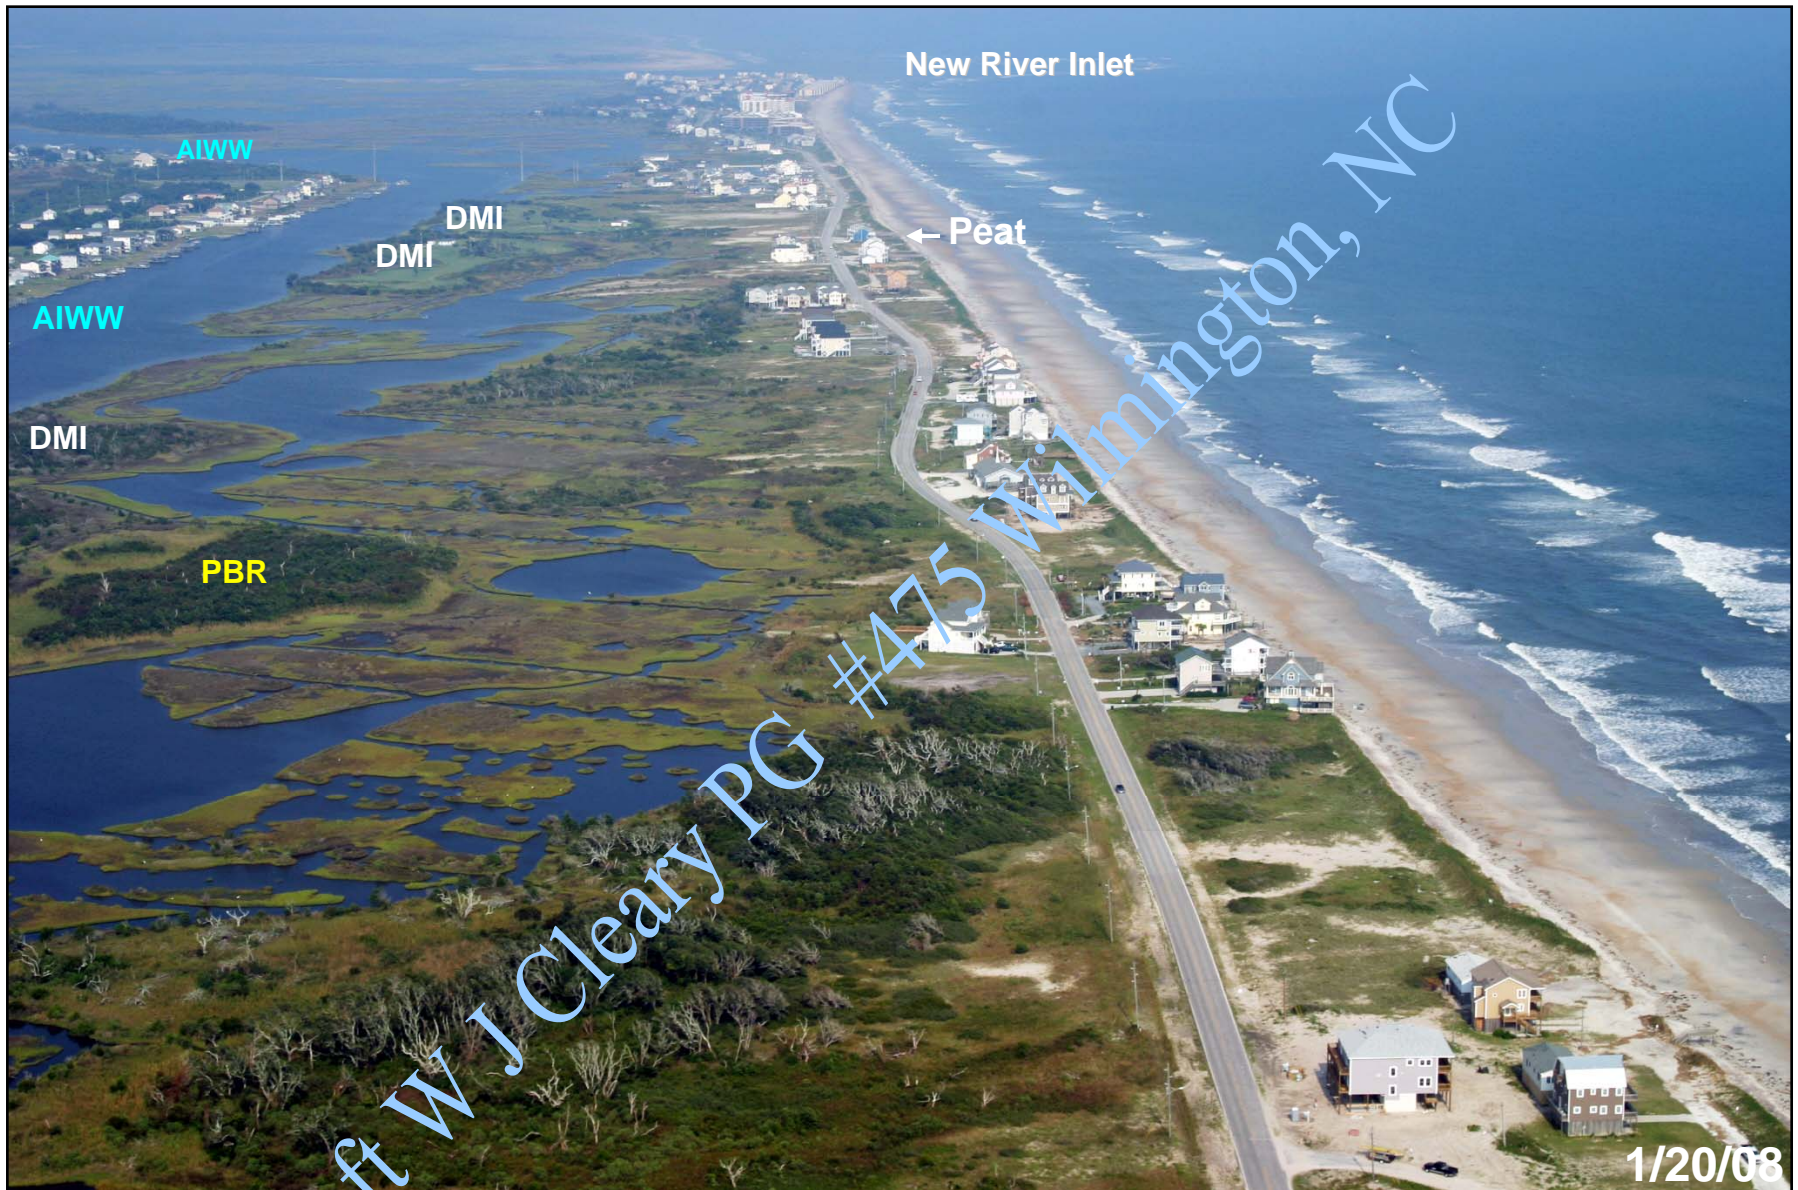
Figure 20. North view (1/20/08) of the northern segment of North Topsail Beach. Note an almost continual line of Dredge Material Islands (DMI) that separates the AIWW from the marsh filled NTB backbarrier. A small remnant of a Pleistocene Barrier is identified (PBR)

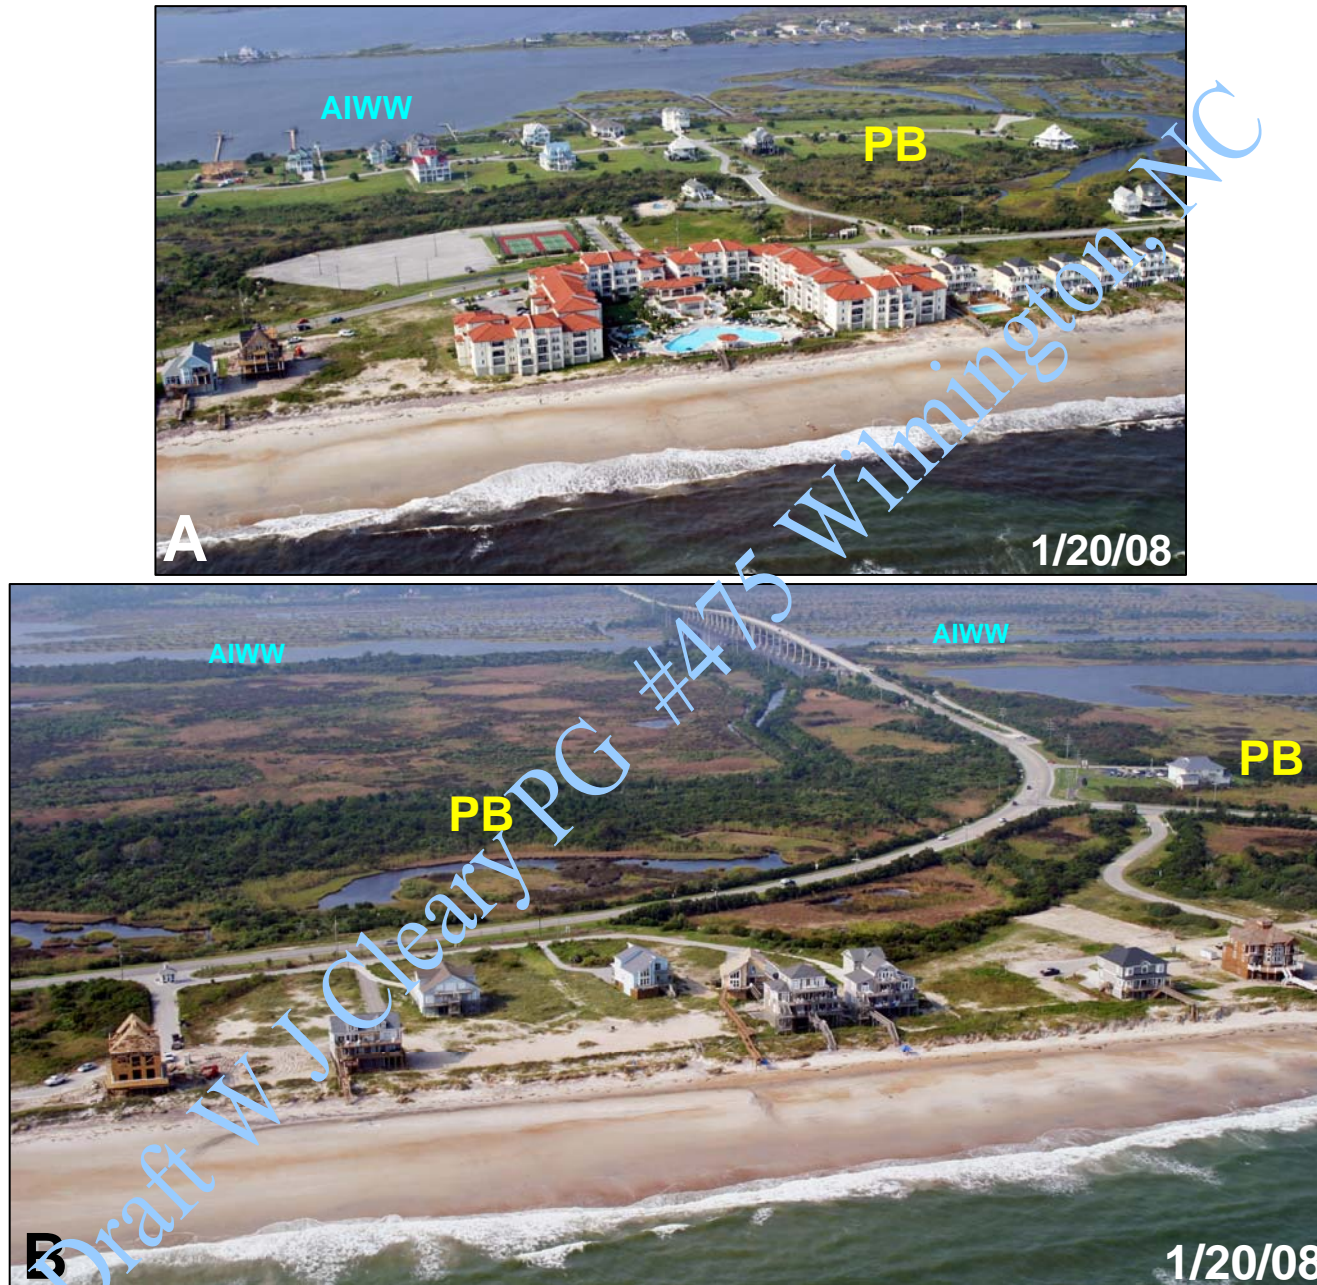
Figure 21. Landward views (1/20/08) of North Topsail Beach. A. View of development on the old barrier remnant (PB) Note the proximity of the landward margin of NTB. B. View depicting a Pleistocene Barrier (PB) in close proximity to the landward margin of NTB. The old barriers have portioned the estuary lands into distinct compartments.
