Historic and Future Inlets Along Topsail Island

William J. Cleary

5 October 2014

Historic and Future Inlets along Topsail Island

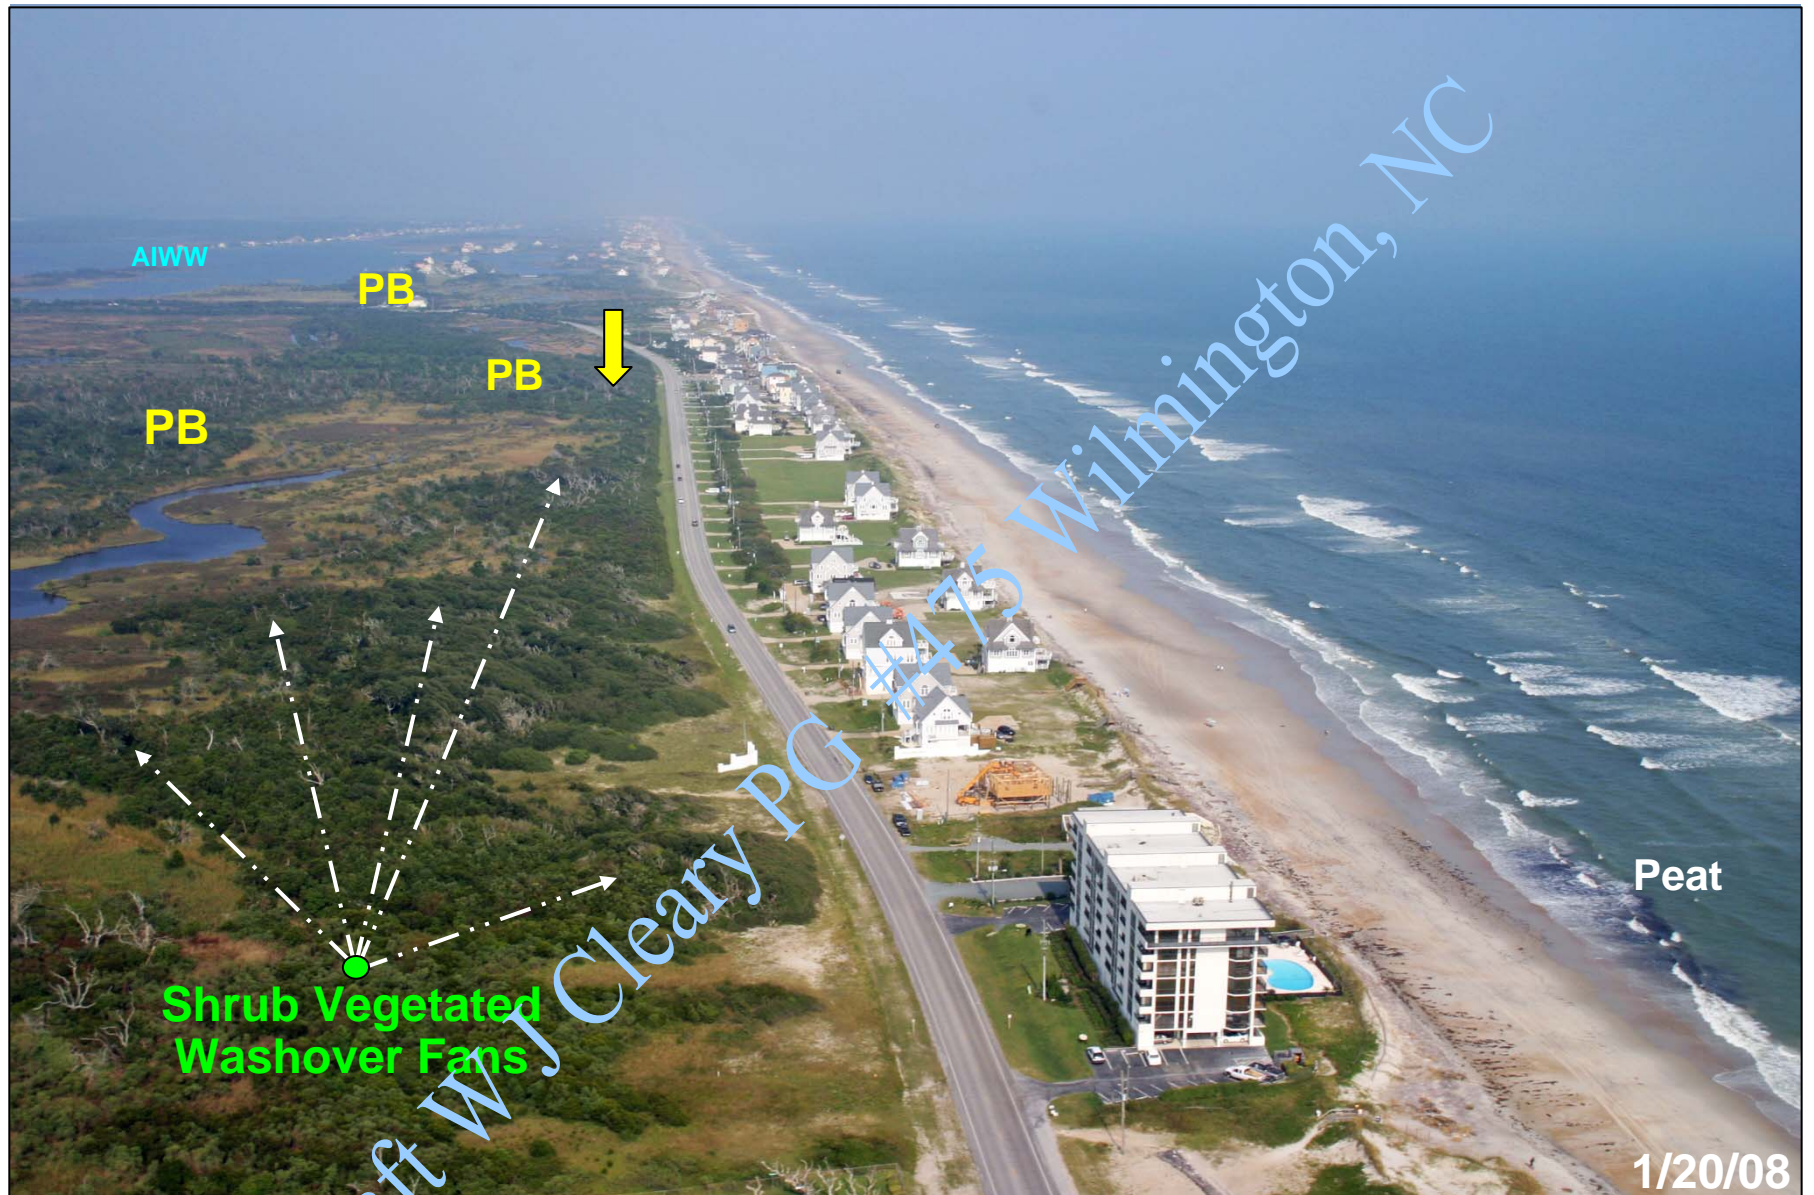
Figure 22. Northward view (1/20/08) of North Topsail Beach immediately southward of Highway # 210 high rise bridge.. One of the Pleistocene Barriers has coalesced with the modern island (Yellow arrow). Note the peat on the lower foreshore. Old washover fans are delineated by the crenulated outline of shrubs. Historic Barren Inlet lies immediately to the south.

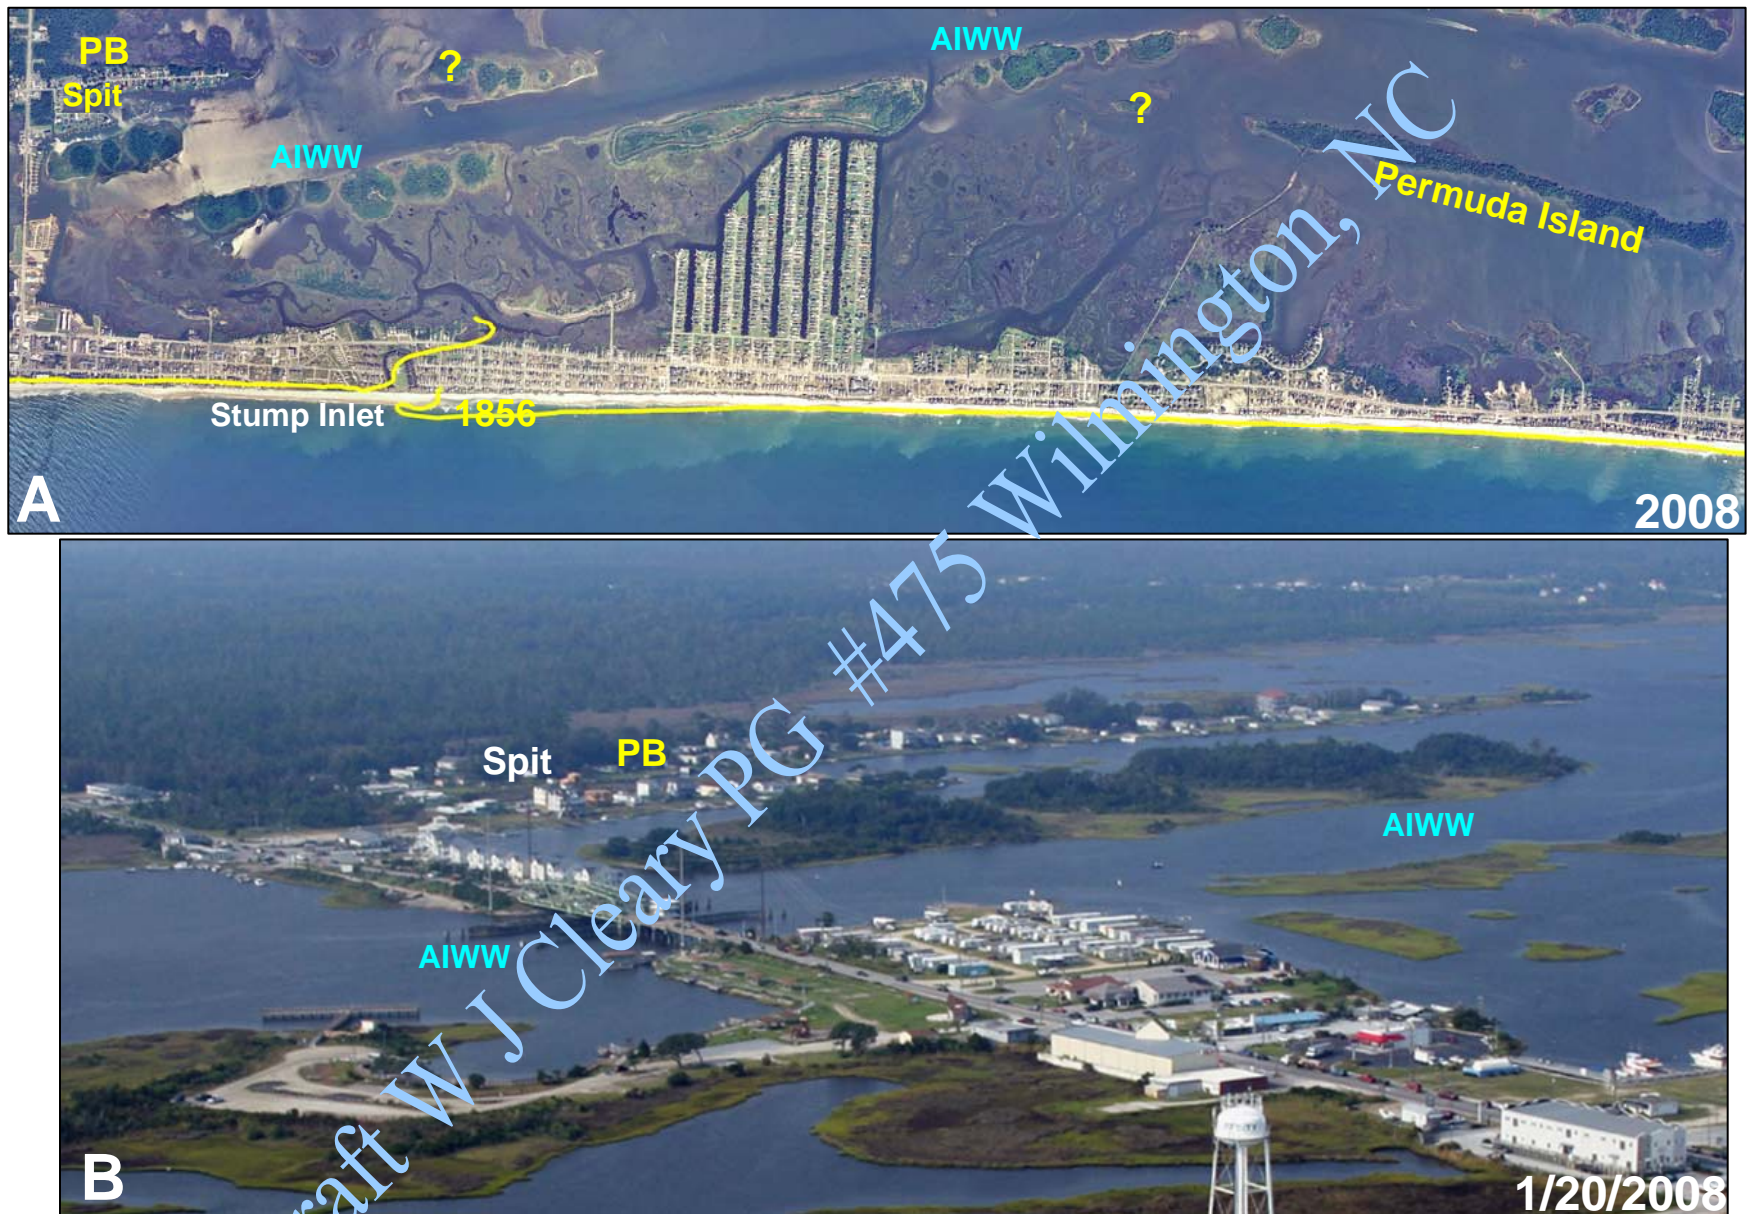
Figure 23. Views of Topsail Beach. A. View of Surf City and Stump Inlet's migration pathway. The Pleistocene barrier spit attachment point is near the bridge. It and the small forested islands (?) are remnants of a once continuous barrier chain. Permuda Island (top) represents. Notice the position of the 1856 shoreline, erosion rates in this area are low. B. Landward view of Surf City and the point of attachment for the Pleistocene barrier spit. Most of the old barriers have been eroded in this area with only a few very small remnants preserved.
