# Town of North Topsail Beach

## North Topsail Beach Shoreline Protection Project

### Phase I Contingency Plan

March 2, 2015

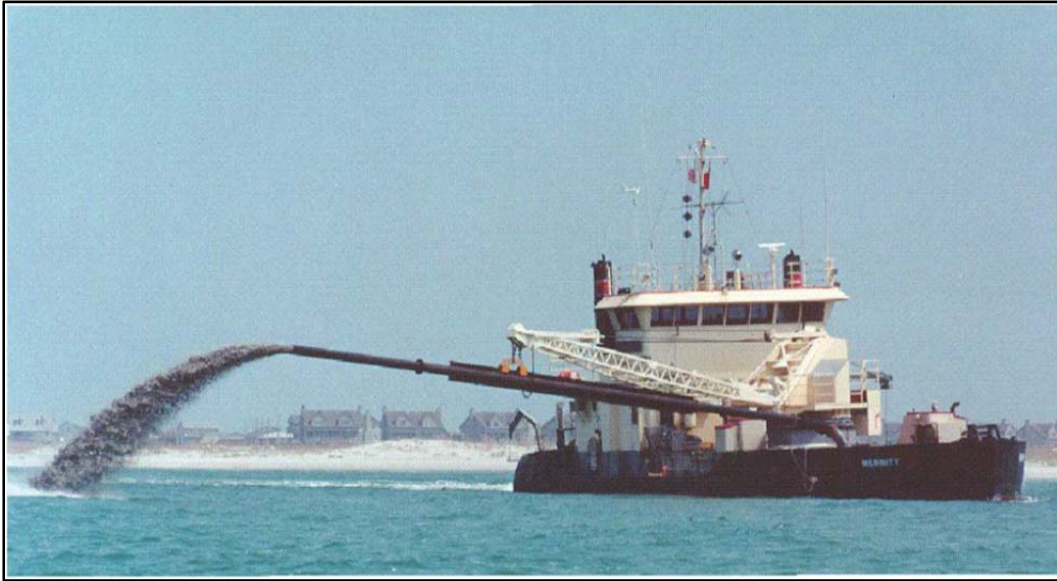
Figure 1. US Sidecast dredge *Merritt* used to maintain navigation channels in Cedar Bush Cut and the Ocean Bar Channel at New River Inlet (Courtesy of USACE Wilmington District Website).

This alternative involves close coordination with the USACE Wilmington Navigation Branch in an attempt to influence their routine maintenance of the ocean bar channel using USACE sidecast and hopper dredge plants (Figures 1 and 2) in such a way as to possibly have some positive impact on sediment movement around the inlet from north to south. Analysis of changes in the ebb shoal as shown on satellite and aerial photographs as well condition surveys of the inlet conducted by the USACE may provide guidance on preferred channel alignments that could assist in a preferential reconfiguration of the ebb shoal. Depending on budgetary constraints, the USACE surveys the channel several times per year to identify the deep water channel and provide mariners with Waypoints to locate the channel position. An example of the surveys performed by the USACE is provided on Figure 3 which shows the bathymetry data collected between January 21<sup>st</sup> and February 4<sup>th</sup>, 2015 in the vicinity of the New River Inlet complex.

This type of dredge allows for beach disposal of dredged sand. Maintenance of Cedar Bush Cut and the ocean bar channel have historically been accomplished using a combination of self-propelled hopper dredges, side cast dredges, and occasionally contract cutterhead suction dredges (Figures 1 and 2).

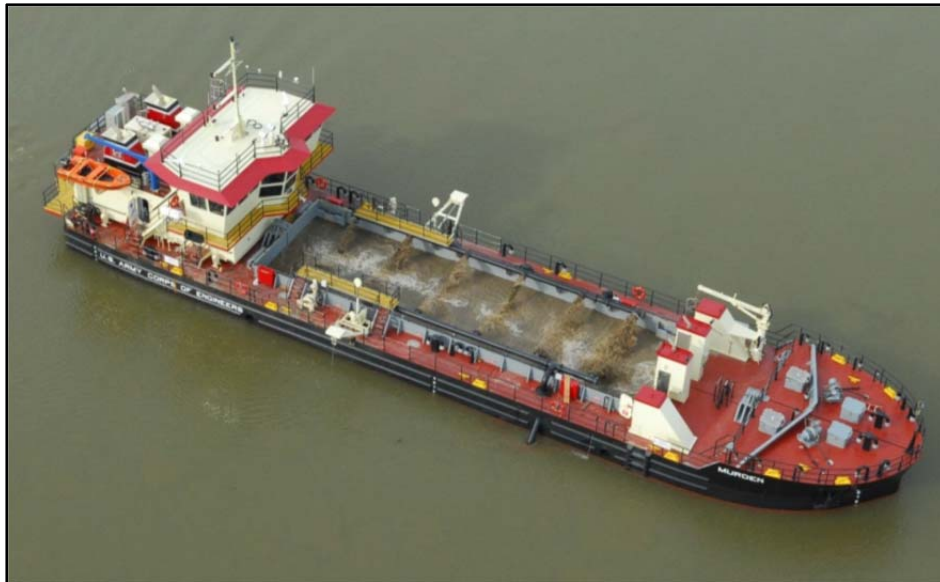
Figure 2. Self-propelled hopper dredge (*Murden*) used to maintain navigation channels in Cedar Bush Cut and the Ocean Bar Channel at New River Inlet (Courtesy of USACE Wilmington District Website).

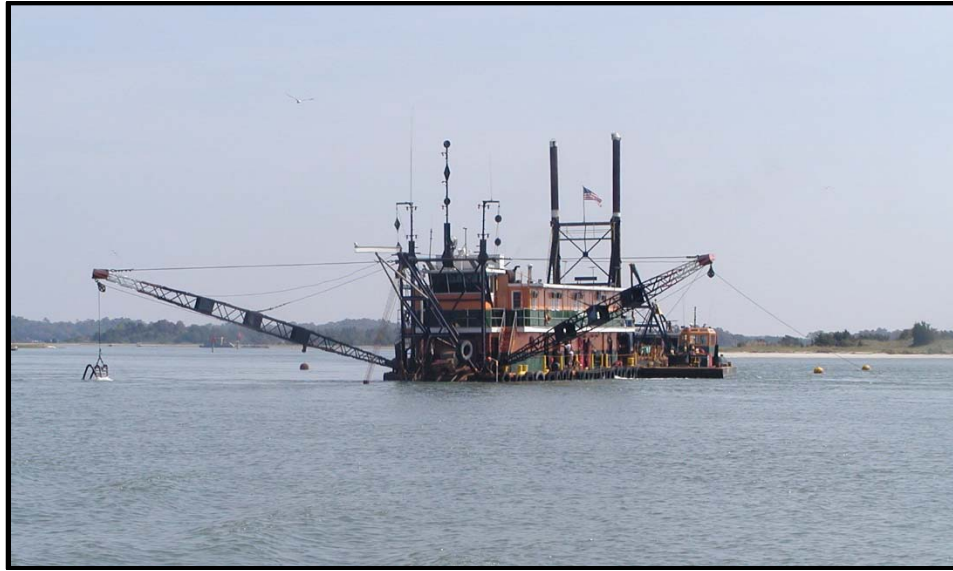
Figure 6. Cutterhead suction dredge comparable to the type used to maintain navigation channels in the AIWW and Channel to Jacksonville (Courtesy Cottrell Contracting Corporation: *Dredge Richmond*)

Historically, the U.S. Army Corps of Engineers (USACE) has been responsible for maintaining the federally authorized navigation channels in New River, the AIWW, Cedar Bush Cut and the ocean bar channel of New River Inlet as shown in Figure 5. Maintenance of the Channel to Jacksonville and the AIWW crossing has historically been accomplished using cutterhead suction dredges similar to the one shown in Figure 6.

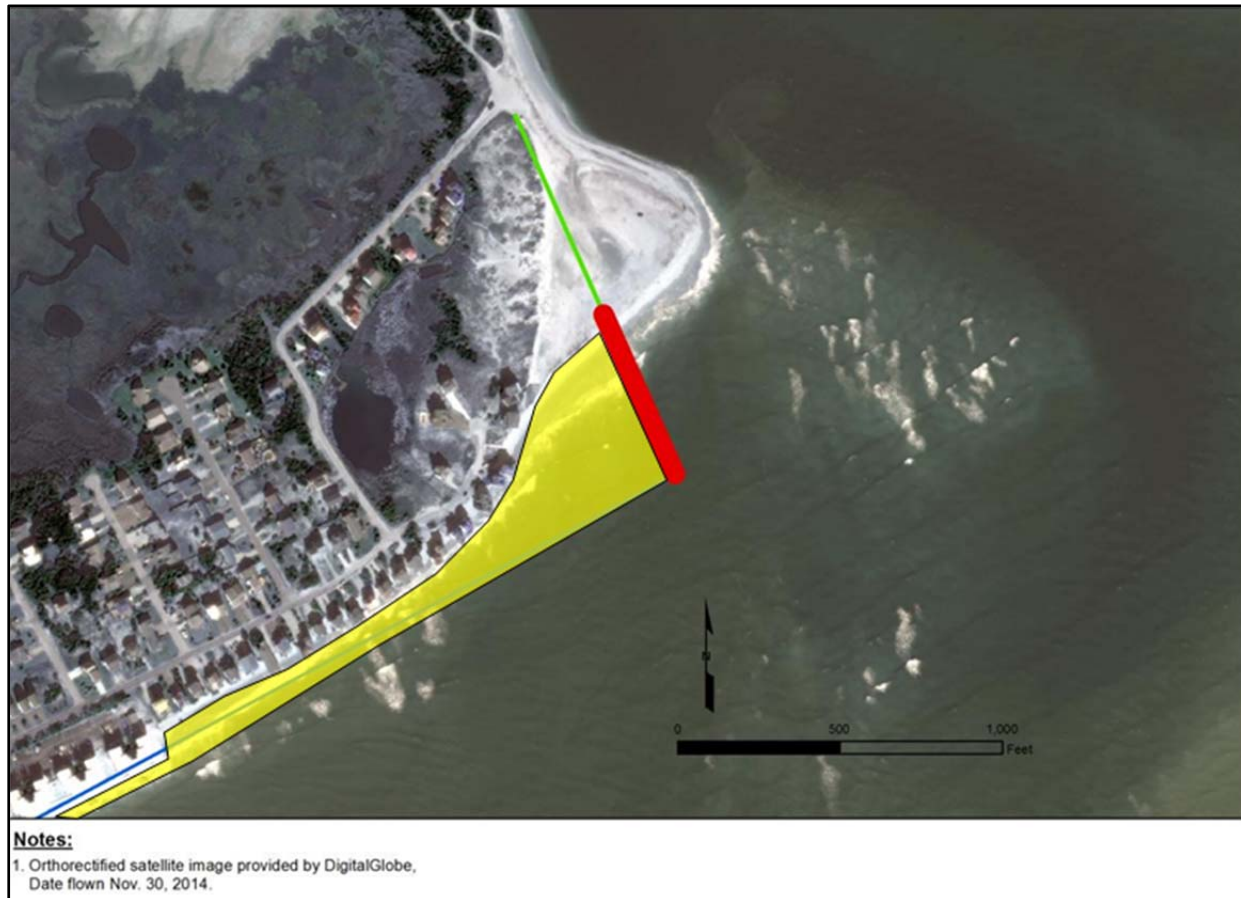
Figure 14. Conceptual rendering of a terminal groin at the north end of North Topsail Beach.

The exact locations and dimensions of a terminal groin would depend on the portion of shoreline that the structure was designed to influence. Substantial data collection, modeling, and engineering design would be required to make such determinations. Figure 11 shows a conceptual diagram of a terminal groin at the north end of North Topsail Beach. The structure would likely be composed of two distinct sections. The seaward section (red) would be a rubble mound structure composed of stone with a low enough crest elevation to allow sediment to pass over the top of the structure during periods of high tide. The stone structures would also be constructed with relatively large voids between the stones to facilitate sediment movement through the structures. The landward section or shore anchorage section (green) would be constructed with sheet piles (either steel or concrete).
